SF-Rima - Project Report # 8

Oregon Natural Resources Council (now: Oregon Wild) Commercial stormwater retrofit – Demonstration project

5825 N. Greeley Ave., Portland, OR

5,750 sq.ft. SF-Rima™
Constructed in 2002

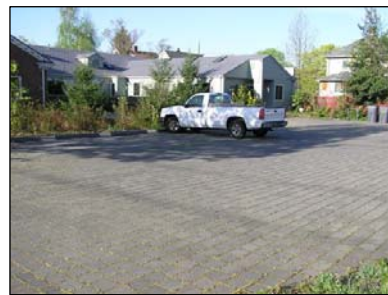
- Remove all existing asphalt
- Install 5,500 sq.ft. SF-Rima for parking lot and 250 sq.ft. for patio
- Install a 1,700 gallon rain harvesting system to provide irrigation water

- The entire site has been completely disconnected from the combined sewer system.
- The project includes two relatively new technologies – a rain harvesting system and permeable paving stone system.
- The large infiltration basin is integral to the landscaping at the building entrance.
